Docket No. 217 – Development and Management Plan Inspection

Northeast Utilities Service Company Certificate of Environmental Compatibility and Public Need for the construction of a 345-kV electric transmission line and reconstruction of an existing 115-kV electric transmission line between Connecticut Light and Power Company's Plumtree Substation in Bethel, through the towns of Redding, Weston, and Wilton, and to the Norwalk Substation in Norwalk, Connecticut.

Date: August 30, 2006

Location: Transition Stations: Hoyts Hill, Archers Lane, Norwalk Junction

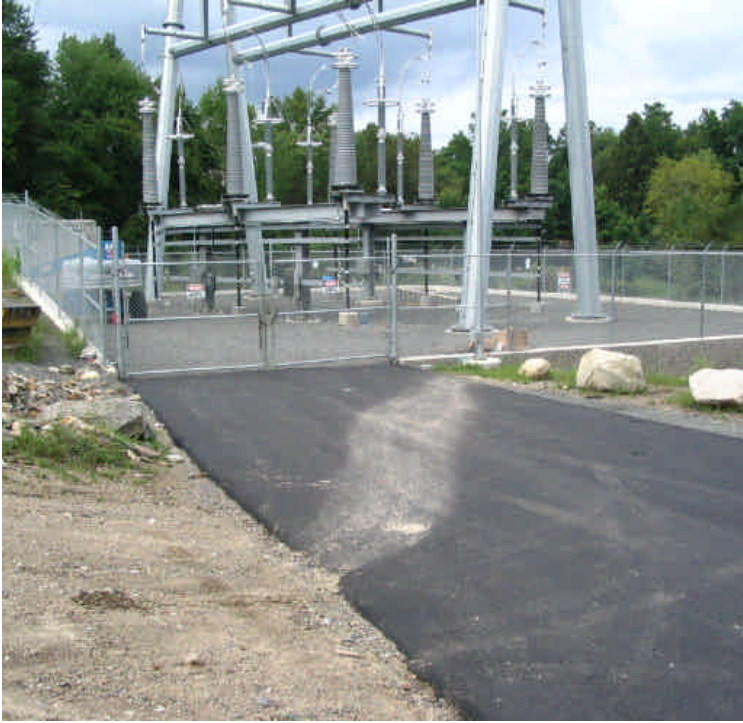
| Areas of Inspection | Observation | Recommended Action | Corrected Actions |
|---|--|--|--|
| Access Roads and Adjacent Roadways | - Hoyts Hill: Access is gained off Hoyts Hill Road. The driveway was recently paved. An apparent stormwater run-off path was noted here. 8/30/06 | -The gully will be filled in if necessary now that the driveway is paved. Asphalt curbing and grading is still proposed for the area. 8/30/06. | -N/A |

Hoyts Hill Transition Station: Photo on the left shows the paved drive up to the station with an apparent stormwater run-off path. Grading work is proposed and will occur soon. Photo on the right shows the remaining gully to the stone pad. The surrounding vegetation has helped to stabilize the area. 8/30/06

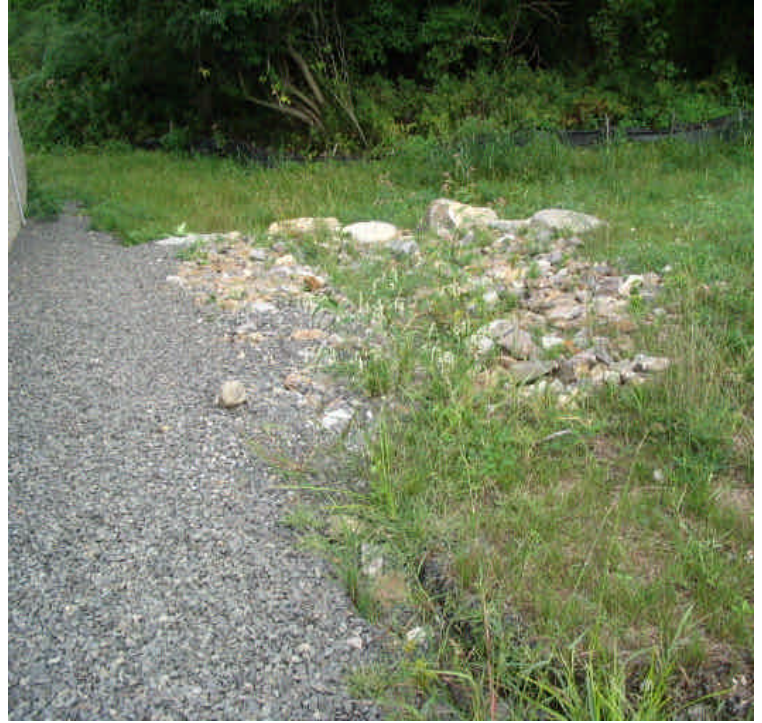
| Areas of Inspection | Observation | Recommended Action | Corrected Actions |
|--|--|--|--|
| Erosion and Sediment Controls | <p>-Hoyts Hill: The perimeter silt fence along the wetlands at the rear of the station remains in good shape. 4/6-8/30/06.</p> <p>- The restored wetland at the base of slope continues to revegetate 8/16-8/30/06</p> <p>-One small gully in the southern slope remains along the stone pad. The surrounding area is</p> | <p>-Fence can likely be removed from most areas as adjacent vegetation is stable. 8/24-8/30/06</p> <p>- Continue to monitor as the area stabilizes. 8/30/06</p> <p>-Determine if the area has stabilized adequately or if the gully still needs restoration. 8/16-8/30/06.</p> | <p>- N/A</p> <p>- N/A.</p> <p>- Needs attention when feasible</p> |

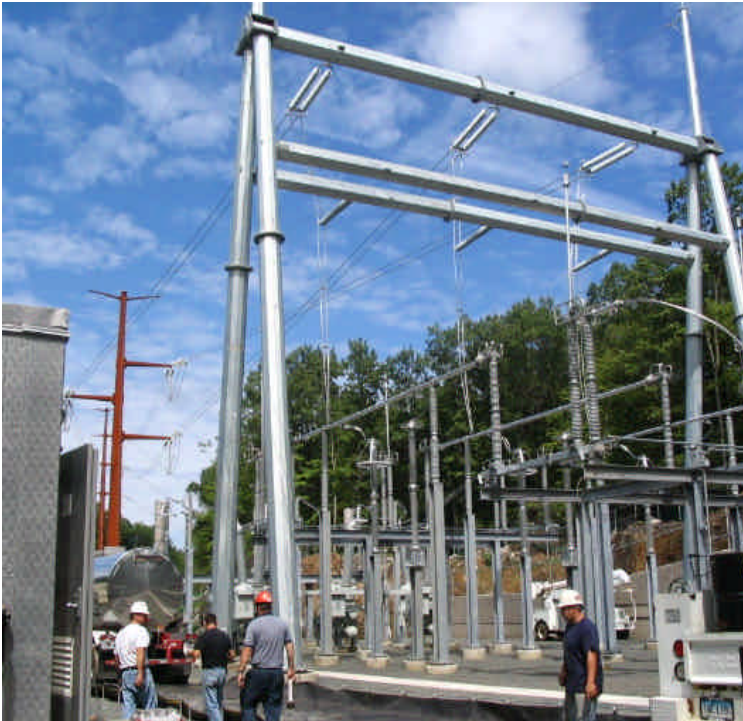
| Areas of Inspection | Observation | Recommended Action | Corrected Actions |
|--|--|--|--|
| Foundation construction | <p>-At Archers Lane, 345kV crews had oil deliveries made to the tanks here. 8/30/06</p> <p>-At Norwalk Junction: Work continues on the structures and equipment in the station pad. Wire pulling crews for overhead work were also present on site. 8/30/06.</p> <p>- The adjacent storage center built an earthen/fabric berm along the silt fence adjacent to the site. 5/25-8/30/06</p> | <p>-Good controls were in place. 8/30/06</p> <p>- None at this time. See erosion control section 6/1-8/30/06</p> <p>- This is not project related/jurisdictional or covered under the permit held by NU. 5/25-8/30/06</p> | <p>-N/A</p> <p>- N/A</p> <p>- N/A – not project jurisdictional</p> |

| Areas of Inspection | Observation | Recommended Action | Corrected Actions |
|---|--|--|---|
| Spills and Material Storage | - No obvious drips or spills were noted at the inspection. 8/30/06 -Good proactive controls were in place at Archers Lane for the oil delivery for the 345kV HPFF portion of the project. | - Continue to keep all vehicles maintained well (i.e. no apparent fluid leaks) if they will be used or stored on site - Report spills immediately, even if they are being controlled. - Take care not to get carried away and to be vigilant when refueling. Avoid refueling in the areas near the wetlands. See proper storage for all materials. | |

Archers Lane: Photo on the left shows a view of the yard. 345kV crews were preparing for oil delivery to the tank here. Good controls were in place. Photo on the right shows the pooled water and sediment against the silt fence at the 1st wetland crossing. Sediment accumulation in the wetland is several inches deep. 8/30/06

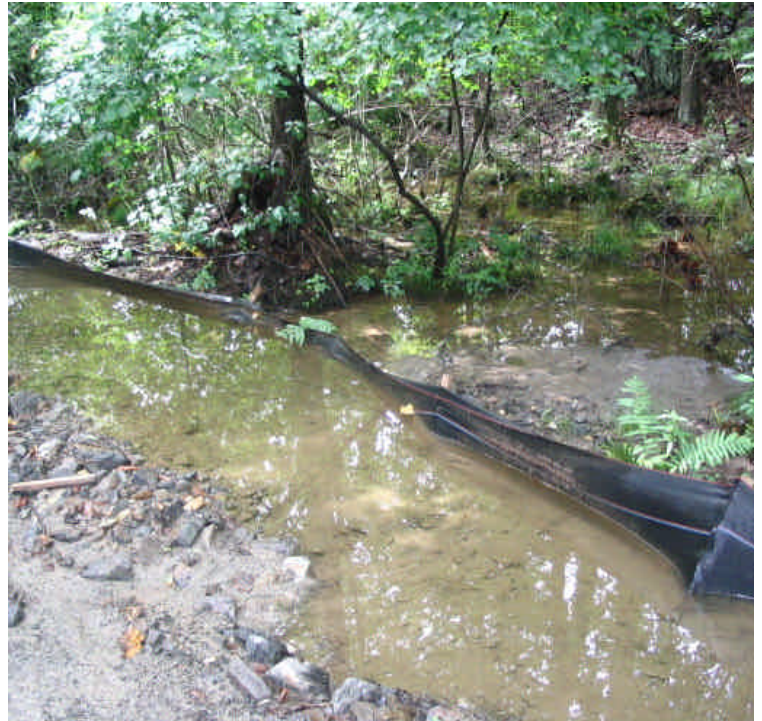
| Areas of Inspection | Observation | Recommended Action | Corrected Actions |
|---|--|--|--|
| | - The silt fence along the access road retains accumulated sediment and pooled water. 8/30/06 Significant sediment still needs to be removed from the wetland 7/26-8/30/06 | - This area will also need some final stabilization measures as this is an ongoing problem. Remove sediment carefully by hand. It is several inches deep in spots 8/9-8/30/06 | - Needs sediment removal. (Future solutions are being discussed) |

| Areas of Inspection | Observation | Recommended Action | Corrected Actions |
|---|--|--|---|
| Erosion and Sediment Controls continued | <p>vegetated and may have sufficiently stabilized. 8/30/06.</p> <p>- Archers Lane: Silt fence along the access road at the 1st wetland was intact but retained pooled water. Significant accumulated sediment remains in the wetland. 7/5-8/30/06</p> <p>- A second area just upgradient had sediment accumulation up to and over the silt fence in the wetland. 8/30/06</p> <p>- A few of the repaired areas upgradient of the 2nd wetland crossing at the ROW started to erode again. 8/16-8/30/06</p> <p>- Haybales remain at the stonewall near Diamond Hill where run-off had been pooling. 8/3-8/24/06</p> <p>- The silt fence where the process stockpile remains in good shape. 8/24/06</p> | <p>Future repairs are planned. 8/30/06</p> <p>- Remove sediment carefully by hand. It was several inches deep in spots. 7/5-8/30/06 NU is looking into final stabilization measures as this is an on-going problem. 8/16-8/30/06</p> <p>- Repair and reinforce controls here as well and remove sediment. 8/30/06</p> <p>- See Overhead report. 8/16-8/30/06</p> <p>- Continue to monitor. 8/24/06</p> <p>- Revegetate the area to the extent practicable but it is still being used for parking 8/9-8/24/06</p> | <p>- Still needs attention</p> <p>- N/A</p> <p>- N/A</p> <p>-N/A until access is complete</p> |

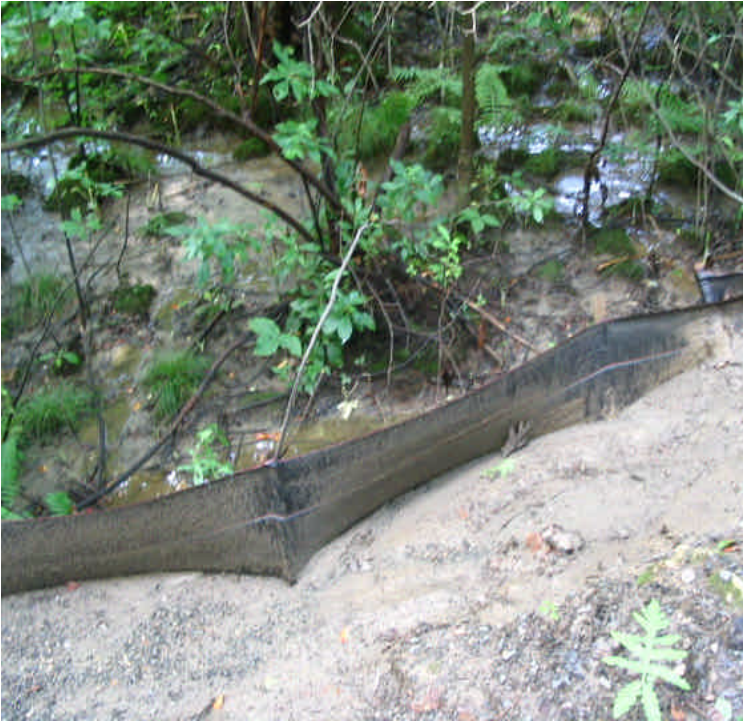
Photo on the left shows sediment accumulation at a spot along the access road just upgradient from the previous photo. Sediment has also reached this portion of the wetland. Norwalk Junction: Photo on the right shows the progress made to the structures and equipment in the yard. 8/30/06.

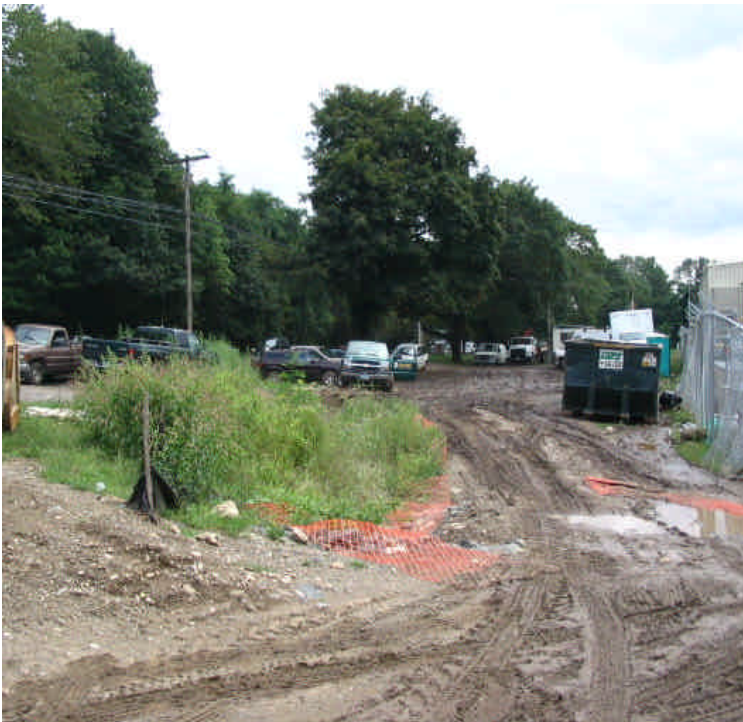
| Areas of Inspection | Observation | Recommended Action | Corrected Actions |
|--|--|--|--|
| Access Roads and Adjacent Roadways continued | <p>- Haybales remain in place where water had pooled in the access road near the stone wall. 8/30/06</p> <p>- Norwalk Junction: Sediment tracking did not appear to be an issue at this time. 5/25-8/30/06.</p> <p>-The front portion of the yard is largely disturbed due to extensive parking here. 8/30/06</p> | <p>-Continue to monitor for more permanent solutions if necessary. 8/30/06</p> <p>-Continue to monitor Rt. 7 at the main access pad. 8/30/06</p> <p>- Stabilize any areas as feasible to reduce disturbance. 8/30/06</p> | <p>-N/A</p> <p>-N/A</p> <p>- Needs attention when feasible</p> |

| Areas of Inspection | Observation | Recommended Action | Corrected Actions |
|---|--|--|---|
| | areas around the perimeter of site should be temporarily stabilized/vegetated due to sediment loading to the swale. 7/26-8/30/06. | feasible (even if it is temporary) 6/1-8/30/06. | |

Photo on the left shows the front of the yard along Rt. 7. A large portion of the site is disturbed for parking. Areas should be stabilized as soon as possible to reduce run-off to the swale. Photo on the left shows the wetland area at the end of the swale with accumulated sediment that should be removed. 8/30/06.

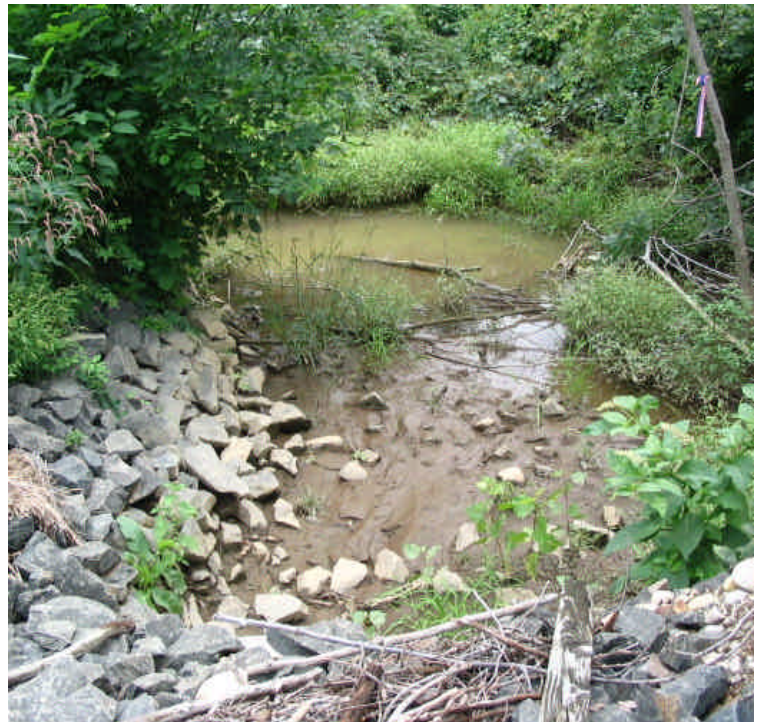
| Areas of Inspection | Observation | Recommended Action | Corrected Actions |
|---|--|--|---|
| | <p>- Norwalk Junction: Perimeter silt fence remain in good shape along the river. 5/17-8/30/06.</p> <p>-The wetland area at the end of the swale, outside the silt fence, adjacent to the river contains accumulated sediment. 6/7-8/30/06</p> <p>- Increasingly larger areas on site have soil disturbance (due to</p> | <p>- None at this time. Continue to monitor controls. 5/17-8/30/06.</p> <p>- The silt is contained and does not yet reach the river. Wetland vegetation was also noted growing here, but silt has built up at the stone outlet and should be removed by hand 6/1-8/30/06</p> <p>- Remove accumulated sediment from the swale and continue to improve</p> | <p>-N/A</p> <p>- Needs attention</p> <p>- Needs attention</p> |
